URGENT FIELD SAFETY NOTICE: ADVISORY**THUNDERBEAT Type S Hand Instruments**

Date: December 20, 2024

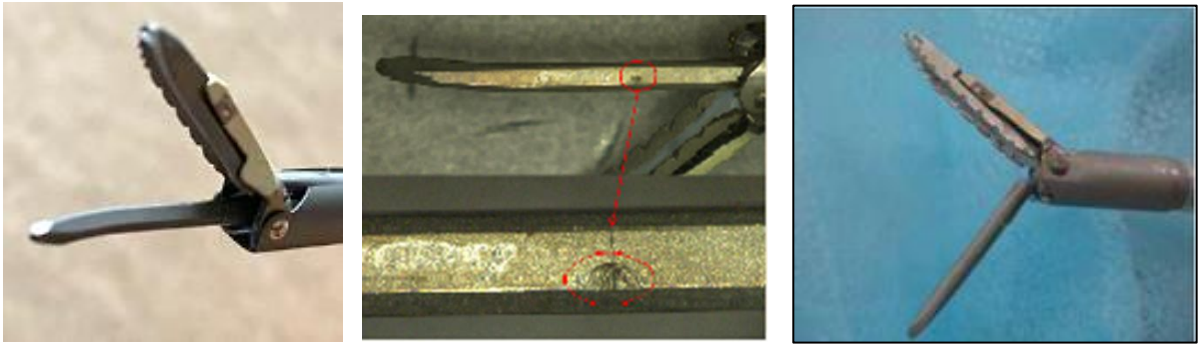
Olympus has been made aware, via customer feedback, of reports where probe tips of the THUNDERBEAT Type S Hand instrument are becoming damaged or are breaking (Reference example in Figure 1), as well as instances of pad damage or detachment (Reference example in Figure 2). These issues can occur when the instructions and warnings in the IFU are not followed, specifically, taking very large bites of tissue, contact with metal while activating, and activation without tissue between the jaws.

Figure 1. Example of Correct Thunderbeat Probe (left), Cracked Probe (Center) and Probe Fracture (right)

In addition, Olympus strongly recommends the use of the ITM (Intelligent Tissue Monitoring) function to prevent probe pad damage due to over-activation and therefore reduce the likelihood of probe tip damage. When using this function, the energy output automatically stops after the target tissue is divided. This is indicated by an audible signal/stop tone. Note: This function may need to be switched to 'on' on your generator, if not already enabled.

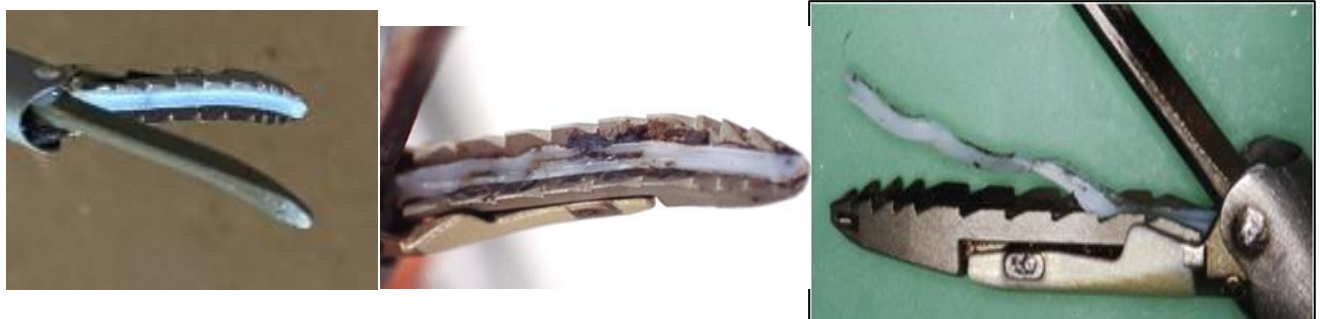
Figure 2. Example Correct Thunderbeat Probe (Left), Tissue Pad Deformation (Center), Tissue Pad Detachment (Right)
